# PROSPER FIRE RESCUE

## FIRE MARSHAL'S OFFICE

## Top Reasons Fire Alarm System Installations Fail Inspection

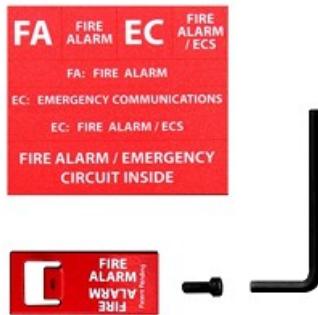
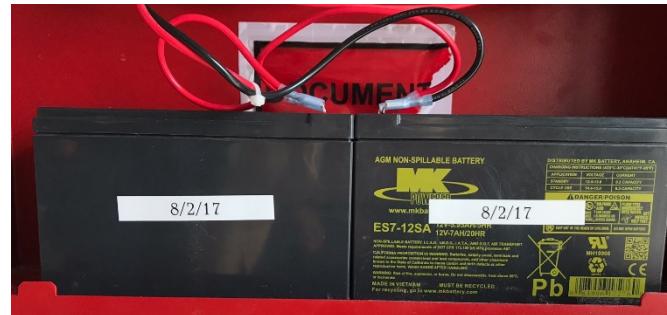
1. A locking Records Retention “Documents Cabinet” metal with piano hinge—[NFPA 72-7.7.2.1](#)
  - a. Final approved/As-Built Drawings
  - b. SF-035 Contractor Certification
  - c. Written basic system operation instructions including bypass codes
  - d. Spare keys
  - e. Panel software
2. Breaker & panel labels with “Red” lockout device – [NFPA 72-10.6.5.2.3](#)
  - a. Battery labeling utilizing a label maker, with contrasting white background & black letters or numbers [NFPA 72-10.6.10.1.1](#)

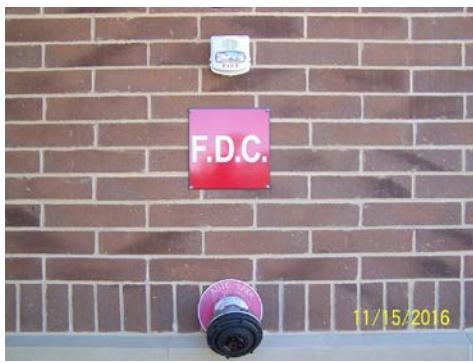
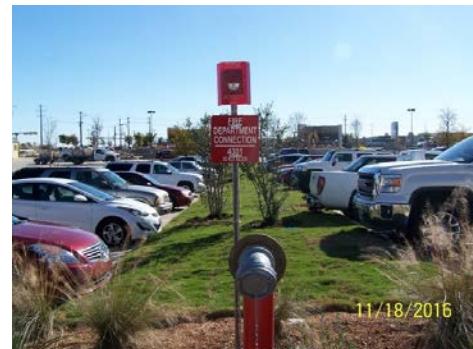
7. Failing to comply with [Prosper Ordinance/Amendments - 907.6.7-Waterflow Notification](#). An exterior audible and visible notification device shall be provided on the exterior of the building above the fire department connection. If a remote FDC is installed, an additional exterior audible and visible notification device shall be located above the FDC seven (7) feet above finished grade

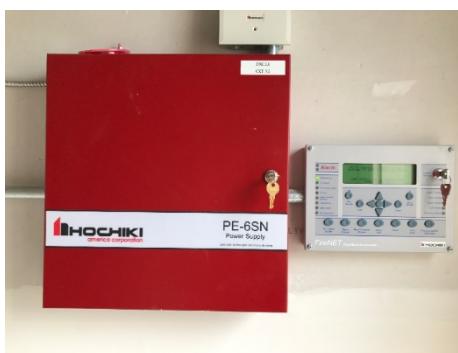
8. Failing to comply with [Prosper Ordinance/Amendments - 907.1.4. Design Standards](#). "Riser rooms shall be equipped with an annunciation panel". [Exception](#), when the fire alarm control panel is installed in the riser room.

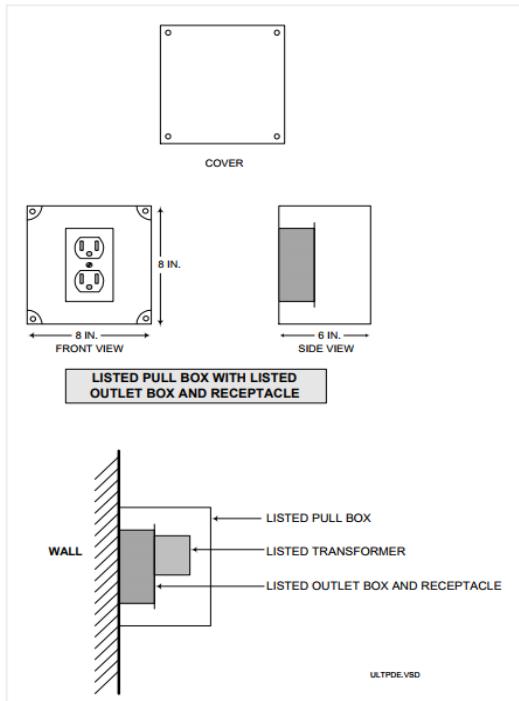
#### Installation Using Conduit

Requirement	Commercial Fire Sole Path	Commercial Fire Backup	✓
AC transformer lines in flexible conduit.	Required	Required	
AC transformer plugged into unswitched outlet.	Required	Required	
AC transformer plugged into dedicated branch circuit.	Required	Required	
Antenna cable in flexible conduit concealed or covered by motion detector.	Required	Required	
12V battery backup requirement (minimum of 7AH to ensure 24hrs standby + 60 minute transmit).	Required	Required	
AC and battery failure supervision.	Required	Required	
60-minute supervision.	Required	Not Required
